**To:** Sonny Thornborrow, US Forest Service

**From:** Randal English

**Date:** May 28, 2020

**Subject:** Yearly Operations Summary – 2019 Beal Year 12 RO Treatment Season

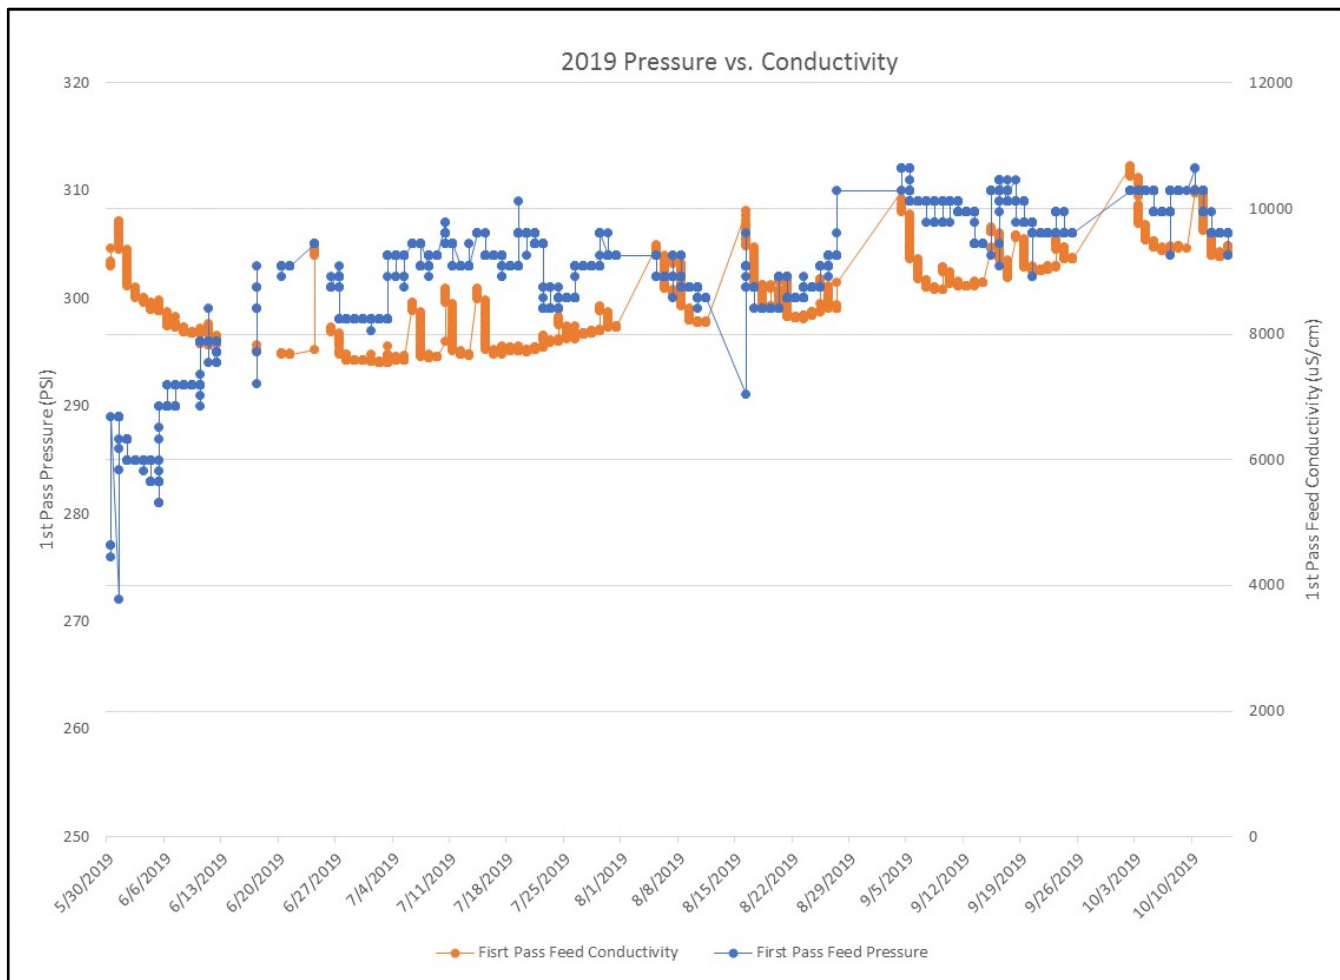
**Figure 1 First Pass Pressure Compared with Raw Water Conductivity**

**Figure 1** below illustrates the relationship between 1<sup>st</sup> pass pressures and 1<sup>st</sup> pass (raw water) conductivity where pressure in the 1<sup>st</sup> pass generally increases as water conductivity increases. However, unlike previous treatment seasons where 1<sup>st</sup> pass pressure fluctuations generally coincide with raw water conductivity, pressures at the start of the 2019 treatment season appear lower and increased over subsequent weeks of RO operation, even though the raw water conductivity was initially decreasing. This abnormality was the result of system operational adjustments which were instituted to maximize the 1<sup>st</sup> pass permeate production and minimize the volume of raw water entering the 2<sup>nd</sup> pass feed through the systems balancing line, although these adjustments resulted in higher than normal operating pressures for 1<sup>st</sup> pass (approximately 280 psi in 2018 vs approximately 305 psi in 2019). The elevated flows through the balancing line resulted from the installation of the new second pass membranes which required higher permeate flows (2<sup>nd</sup> pass feed) than the older 1<sup>st</sup> pass membranes could provide. Several smaller spikes in the raw water conductivity can be observed in **Figure 1** which correlate to short term system shutdowns as described in **Table 2** above. Although system adjustments can help alleviate elevated pressures in the RO system, increased raw water conductivity (in general) will cause increases in the RO operating pressures.

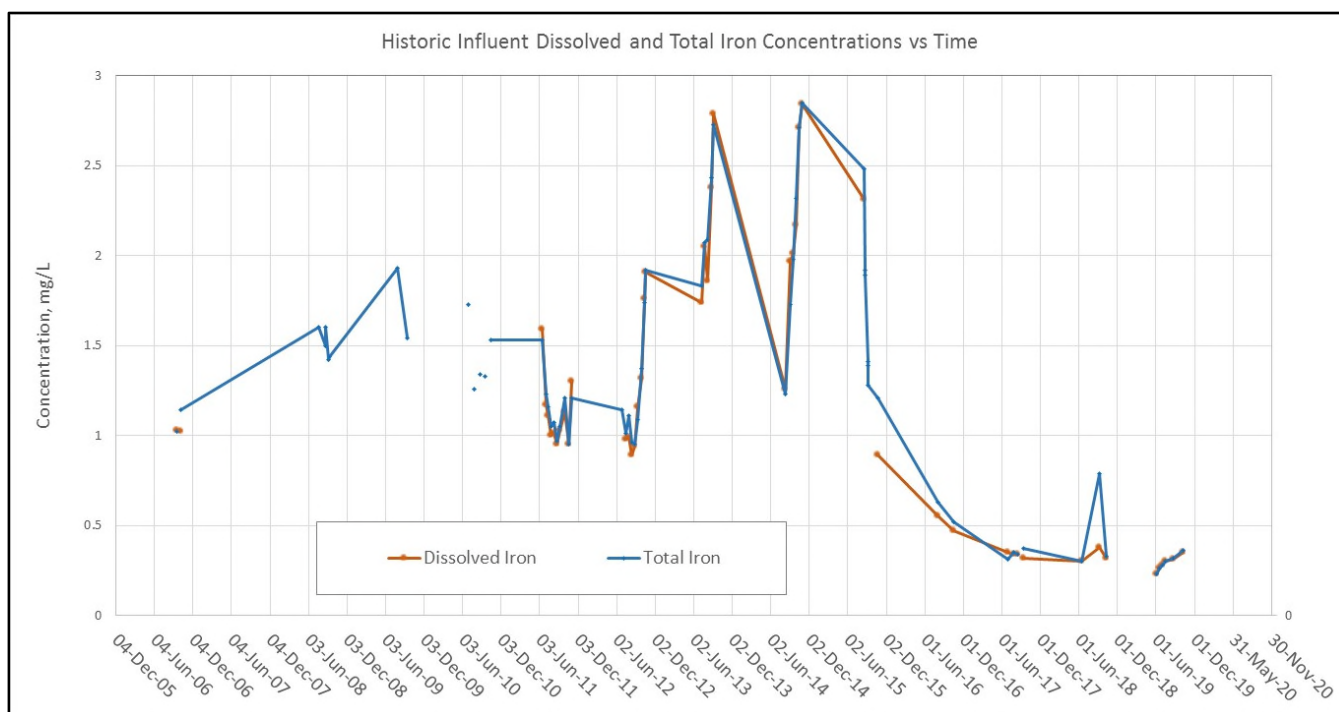
**Figure 2. Dissolved and Total Iron Concentrations from 2011 to 2019**

Historic total and dissolved iron concentrations are shown in **Figure 2** above. The data indicates total and dissolved iron concentration values are nearly identical at varying magnitudes of concentration, indicating that most of the iron present in the leach pad is in dissolved form.

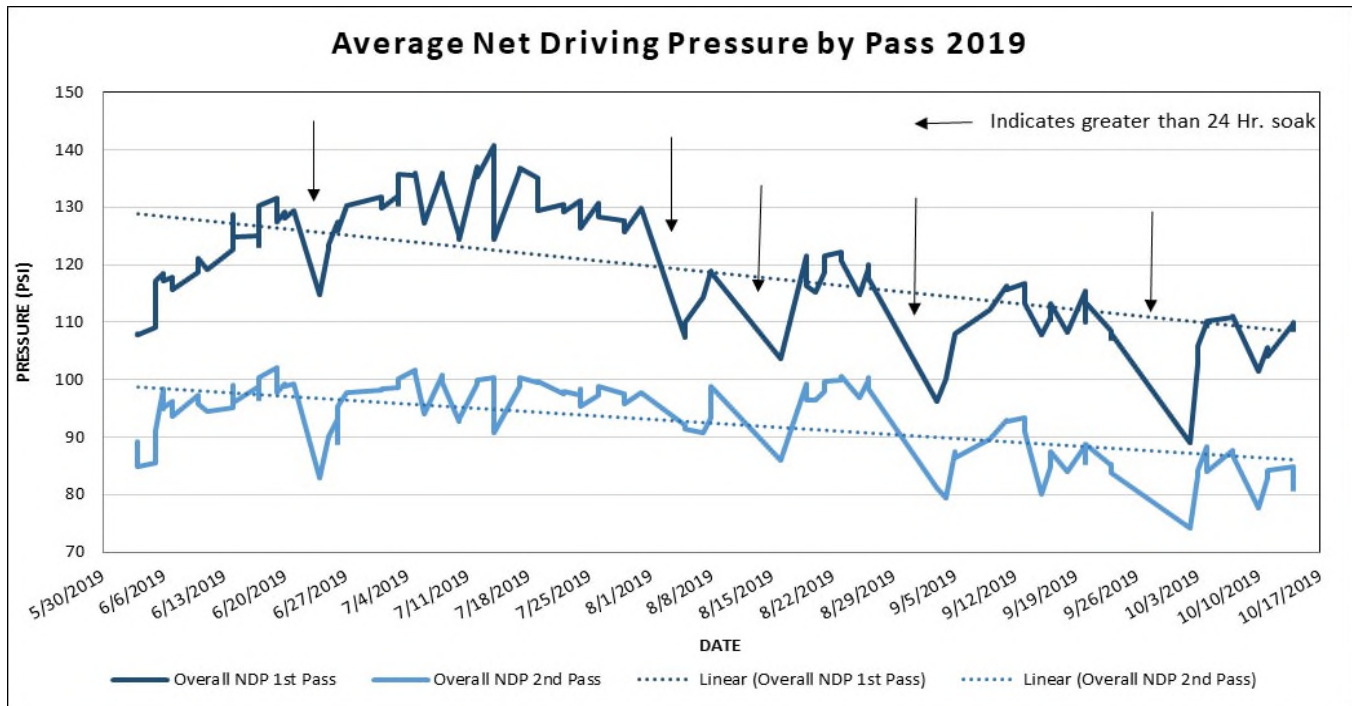
**Figure 6. Average Net Driving Pressure**

When NDP is monitored for each stage of a RO system, problems can be identified between fouling and scaling based on the location of increases in pressure. An increase in NDP in the front stage of a RO indicates possible fouling issues while increases in NDP in a second stage indicates scaling. In general, average NDP increased over the first month of operation during the 2019 season then generally decreased during the second half of the operational season, ending at approximately the same value as at startup (**Figure 6**). **Figure 7**(below) displays NDP data for each array of the Beal RO system.

A slight overall increase in NDP would be expected in normal RO operations, particularly where systems are being operated near the upper limits of capacity for feed water chemistry, such as the case with the Beal RO system. The decreases in NDP throughout the second half of the season correlate with the mid-season cleaning (completed 08/05/2019) and the frequent system downtime which were used as soak events. It would appear that any fouling or scaling that may have occurred during the early season was removed by the midseason cleaning and that the frequent soak events resulted in minimal or no net accumulation of membrane fouling during the 2019 season. Additionally, the data tends to suggest that extended soaking periods can be nearly as effective as the cleaning events.

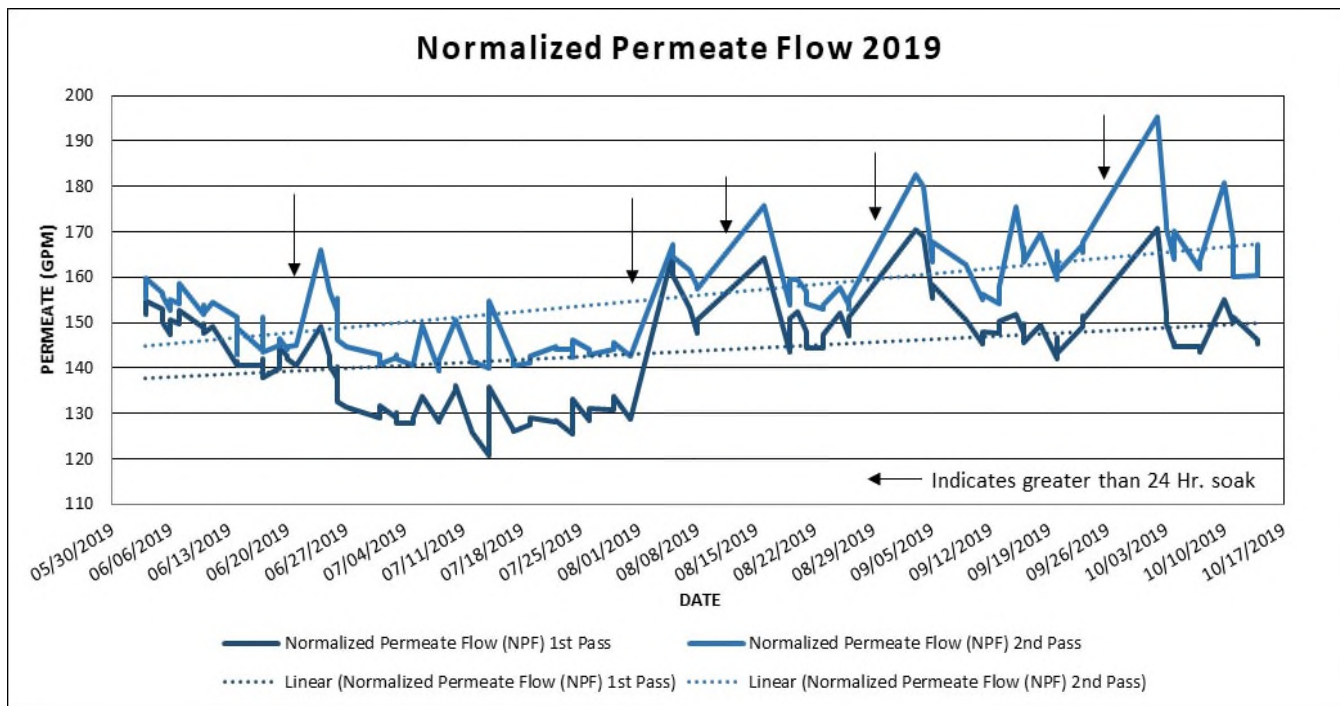
**Figure 8 Beal RO Normalized Permeate Flow**

NPF measures the amount of permeate water that the RO is producing. A decrease in NPF could indicate that the membranes require cleaning while increases in NPF suggest either improved feed water quality (lower TDS), decreases in membrane foulant, possible leakage of brine seals or other membrane damage. NPF should always be evaluated with other operating parameters and take into account any system adjustments that also contribute to any NPF values. For instance, NPF increases combined with increased permeate conductivity may suggest brine seal leakage or membrane damage. In general, NPF in 1st and 2nd passes declined during the first month of operations, stabilizes during the second month, then increases through the remainder of the season (**Figure 8**). This suggests that during early season operations, fouling may have occurred. The removal of foulant during the mid-season cleaning combined with frequent soak periods associated with system down time resulted in improved system performance but still a slight net decrease in 1st pass membrane performance.

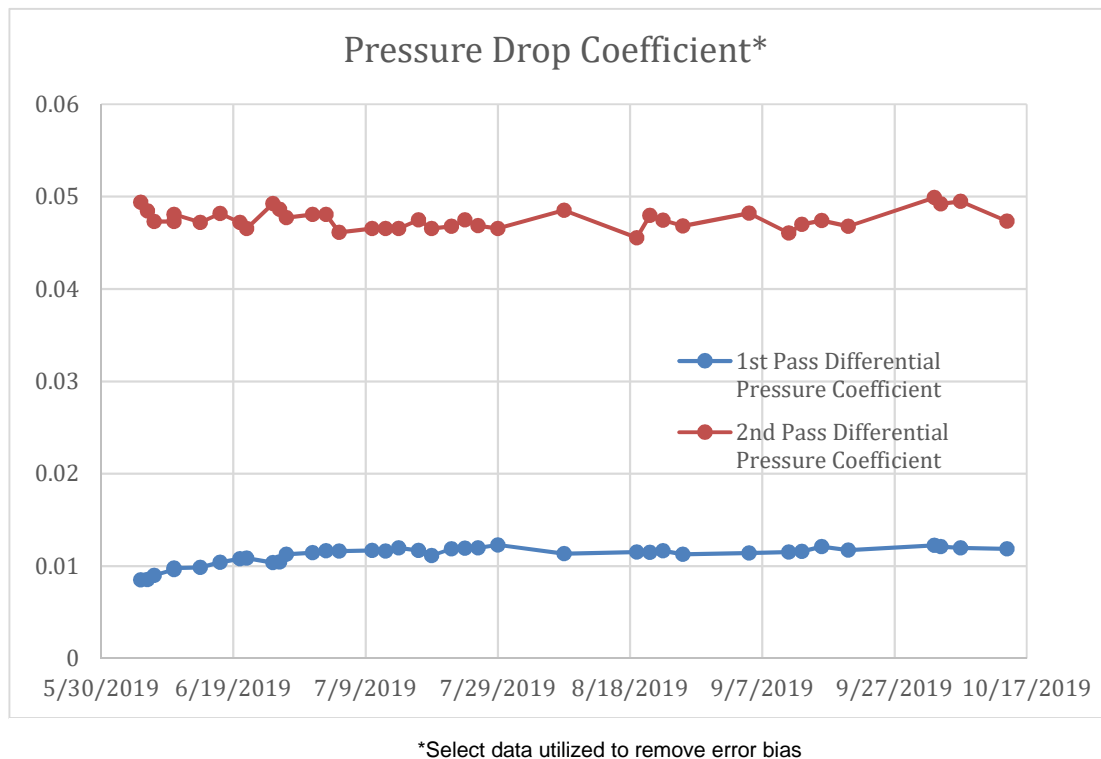
**Figure 9. Calculated Pressure Drop Coefficient**

In general, increases in the differential pressure drop coefficient are often used as an indicator of obstruction to flow (fouling) within the system. Foulant may be associated with particulates, biological growth, or dissolved solids precipitation (scale). Fluctuations in the coefficient can also be attributed to system adjustments, meter calibrations, feed and concentrate valve functionality, and system stabilization following shutdowns / restarts.

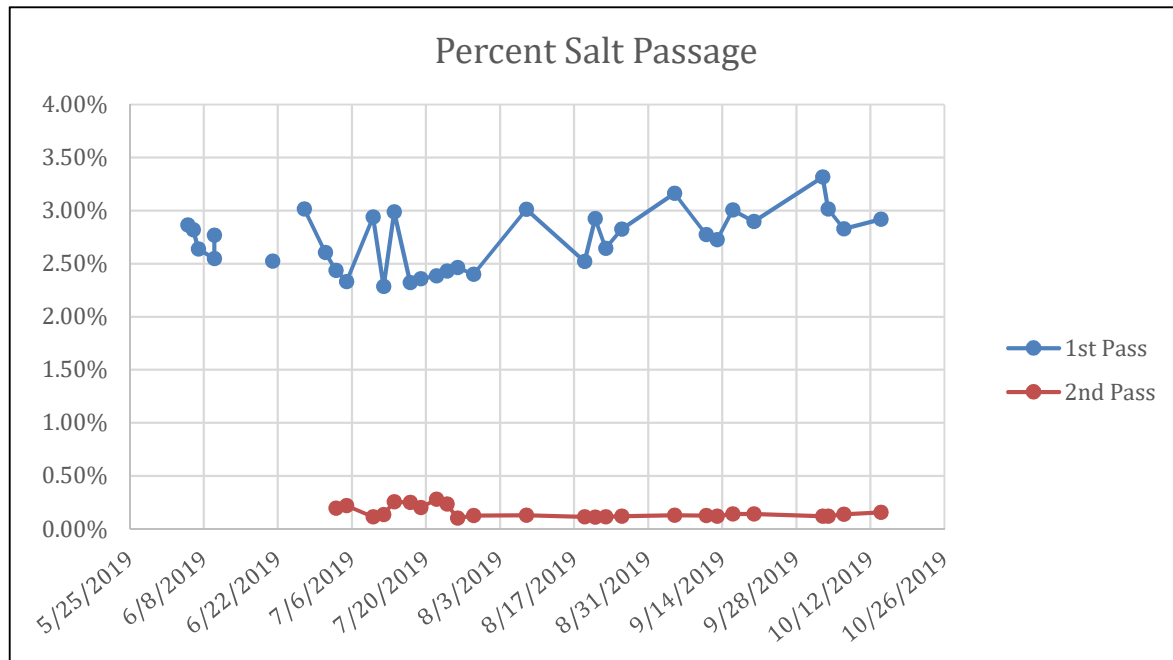
**Figure 10 Percent Salt Passage**

Tetra Tech plans to continue the collection of RO data for the percent salt passage calculation during future operations in order to develop better baseline data, evaluate membrane performance, and refine element cleaning protocols.

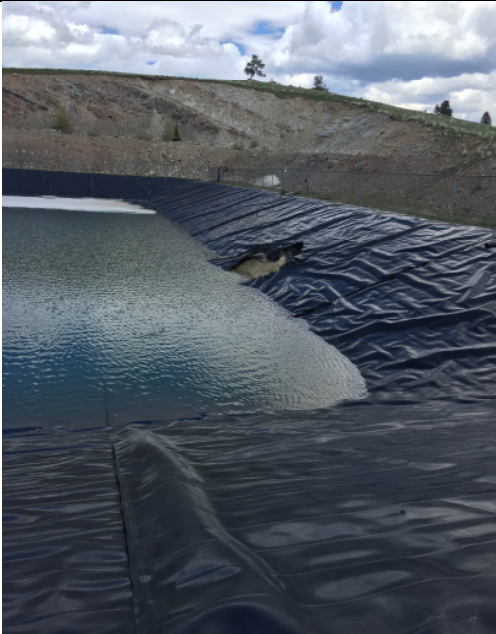
Photo 3. Tear in Freshwater Pond liner spring of 2018.	Photo 4. Freshwater Pond – September 2019.

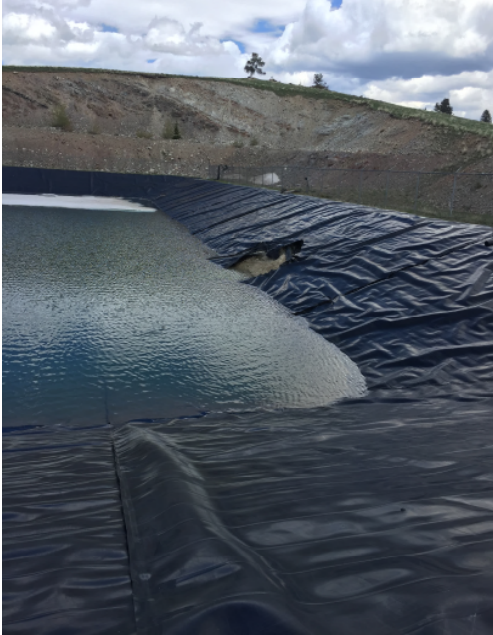
Photo 3. Tear in Freshwater Pond liner spring of 2018.

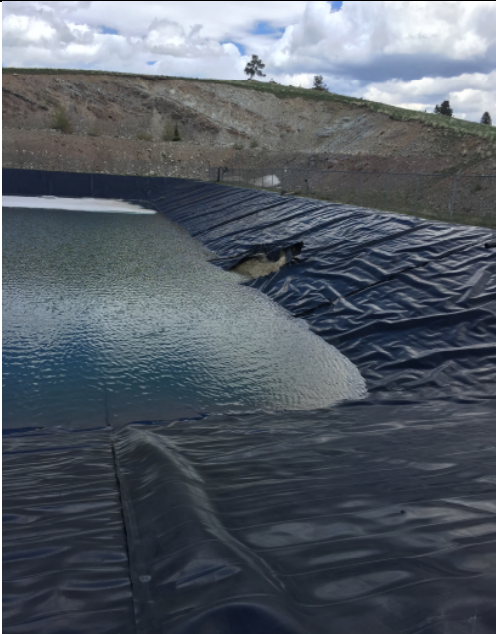
Photo 3. Tear in Freshwater Pond liner spring of 2018.	Photo 4. Freshwater Pond – September 2019.

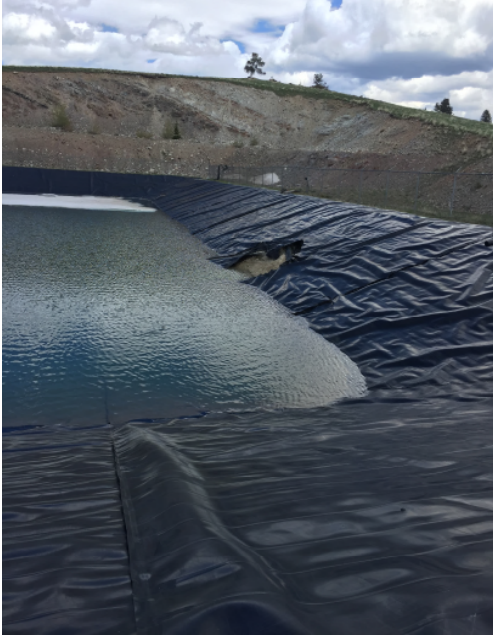
Photo 3. Tear in Freshwater Pond liner spring of 2018.
